WELDING INSPECTION REPORT

OSM Arrival Time: 630 **Project Name:** SAS Superstructure **OSM Departure Time:** 1530 **Prime Contractor:** American Bridge/Fluor Enterprises, a JV

34-0006 **Bridge No: Component: OBG & Tower**

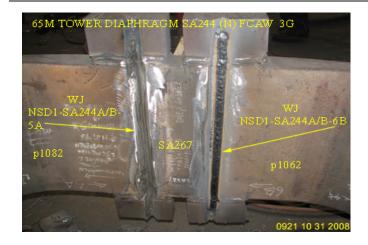
The QA Inspector randomly observed ZPMC welders Zhou Bin ID 067947 (WJ's 5A/6B) and Gao Dong Liang ID 048714 (WJ 9A)), utilizing the FCAW Process in the 3G (Vertical Groove) Position with ZPMC WPS WPS-B-T-2233-B-U3-F, to weld 68M (N) Tower Diaphragm Flange Plate Assembly sections piece marks SA267/p1082 at WJ NSD1-SA244A/B-5A, NSD1-SA244A/B-6B and NSD1-SA244-9A. The QA Inspector randomly observed ZPMC QC under the supervision of ZPMC CWI Liu Hua Jie, monitoring weld parameters. The weld parameters appeared to comply with contract requirements. The attached photograph provides additional detail.
